Manhole Inspection Summary

Manhole # S43C__014MH

Location Address: **E.Fayette St**

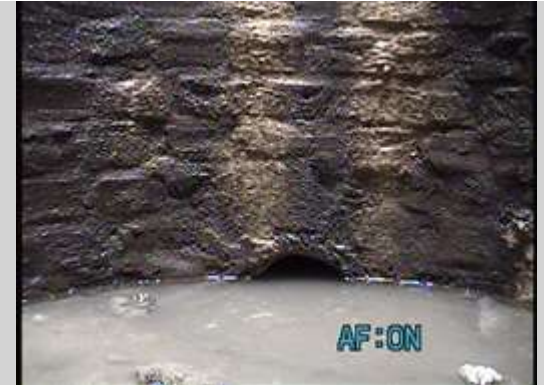
12 O'Clock Outflow

8 in. Circular Gravity Sewer
Pipe Out @ 12 O'Clock

Deposits: ☐ None ☒ **Mud** ☐ Sludge ☐ Debris ☐ Grease

Silt Depth: **3** (in.) Deposits Extent: **Light**
